QUALITY ASSURANCE IN RADIOGRAPHY WITH EMPHASIS ON LIGHT FIELD X-RAY BEAM ALIGNMENT

ABSTRACT

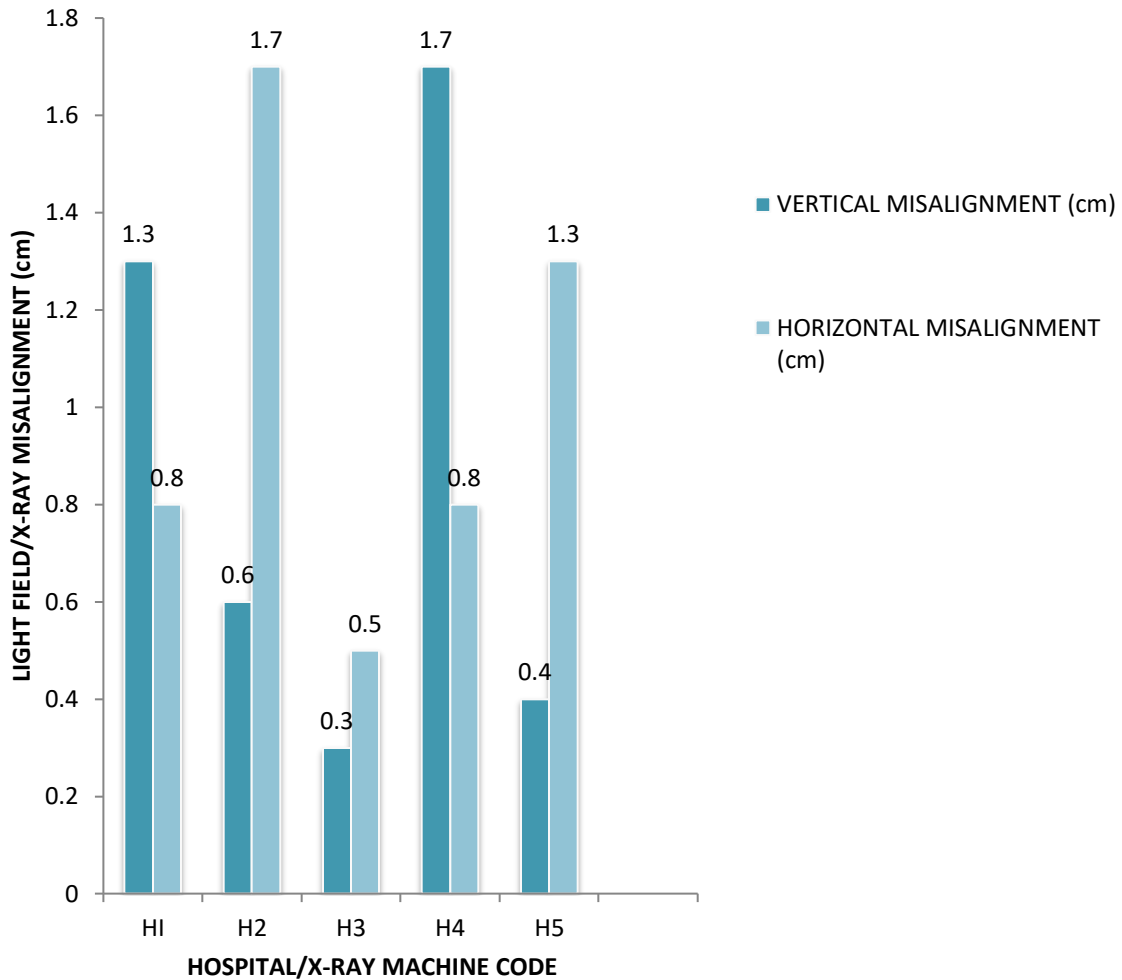
Figure1: A Bar Chart Representing the Light Field/X-Ray beam Alignment Test Results on the 12.5 cm x 12.5 cm Collimator Light Field.

Table 1 and Figure 1 represent the vertical and horizontal deviation of the light field and X-ray beam misalignments of the 12.5 cm x 12.5 cm collimator light field of the various X-ray centers, the percentage misalignment for the vertical axis were: 1.3, 0.6, 0.3, 1.7, and 0.4cm corresponding to H1, H2, H3, H4, and H5 respectively. While the percentage misalignment for the horizontal axis were: 0.8, 1.7, 0.5, 0.8, and 1.3cm corresponding to H1, H2, H3, H4, and H5 respectively. The most vertically misaligned (1.7cm) correspond to 1.7% of the source to the image distance (SID) was recorded on X-ray machine H4, while H2 recorded the most horizontal misalignment of 1.7cm corresponding to 1.7% of the source to the image distance (SID). H3 was seen to have the least misalignment of 0.3cm and 0.5cm on the vertical and horizontal misalignment test respectively. From the analysis, all X-ray machines observed passed the light field and X-ray beam misalignment test is having misalignments of values below the AAPM set limit of 2.5cm (2.5% of the SID) vertical and horizontal misalignment.

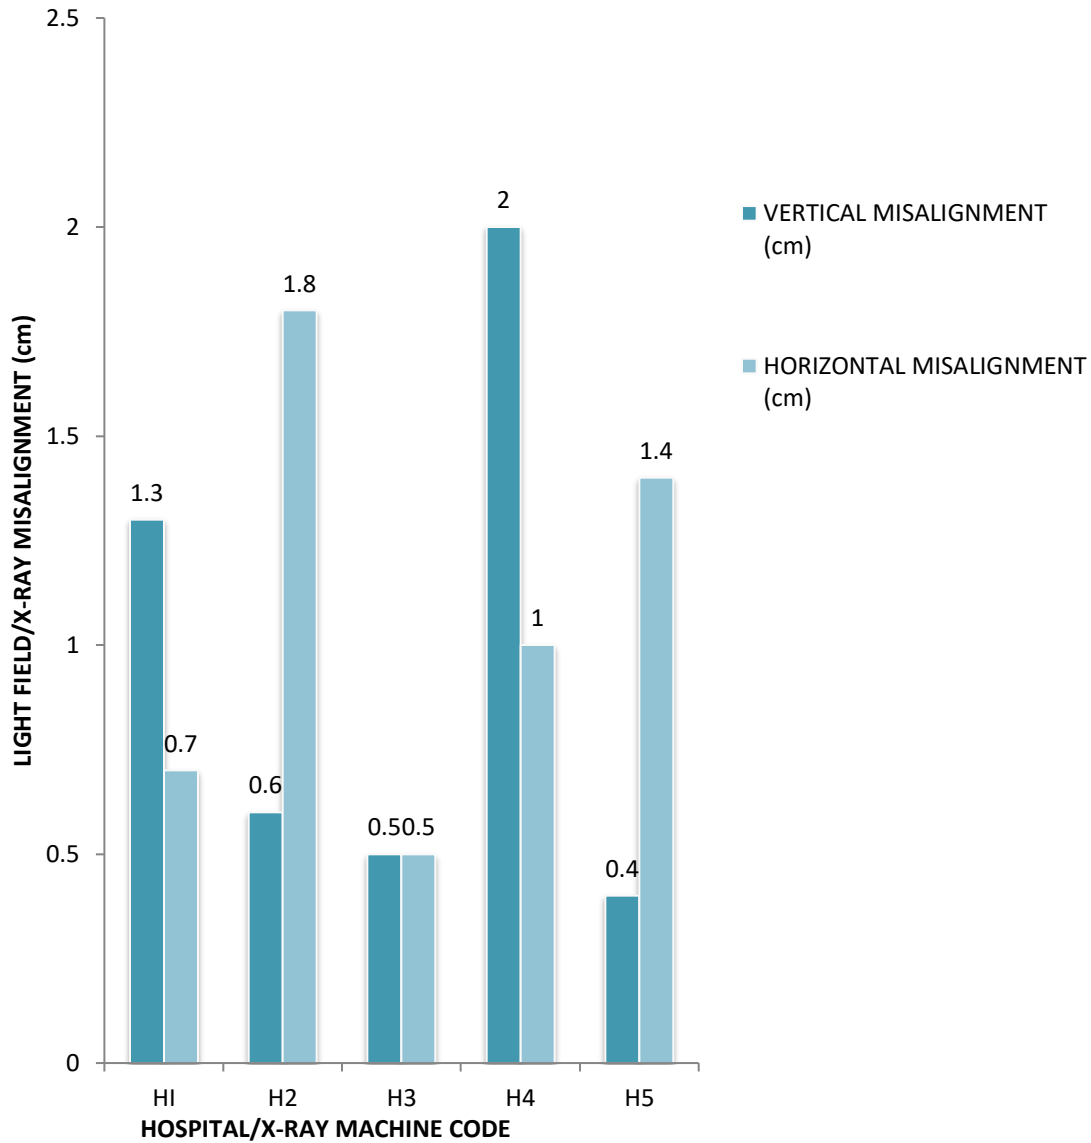
Figure 2: A Bar Chart Representing the Light Field/X-Ray beam Alignment Test Results on the 22.5 cm x 17.5 cm Collimator Light Field.

Table 2 and Figure 2 represent the light field and X-ray beam misalignment test using a larger collimator light field of 22.5 cm x 17.5 cm. It was observed that, H1, H2, H3, H4, and H5 had vertical misalignment of 1.3, 0.6, 0.5, 2.0, and 0.4cm, with a horizontal misalignment corresponding to 0.7, 1.8, 0.5, 1.0, and 1.4cm respectively. X-ray machines (H4 and H2) recorded the highest vertical and horizontal misalignment of 2.0cm and 1.8cm respectively corresponding to 2cm and 1.8cm of the source to the image distance (SID). Even though H4 recorded the highest misalignment value, this value was seen to be below the AAPM 2.5cm (2.5% of SID) set limit for vertical and horizontal misalignment. Hence H4 passed the light field and X-Ray misalignment test. The least misaligned as shown in figure 1 were H5 representing
