# Causes and Repair Techniques for Distresses in Concrete Pavements

## ABSTRACT

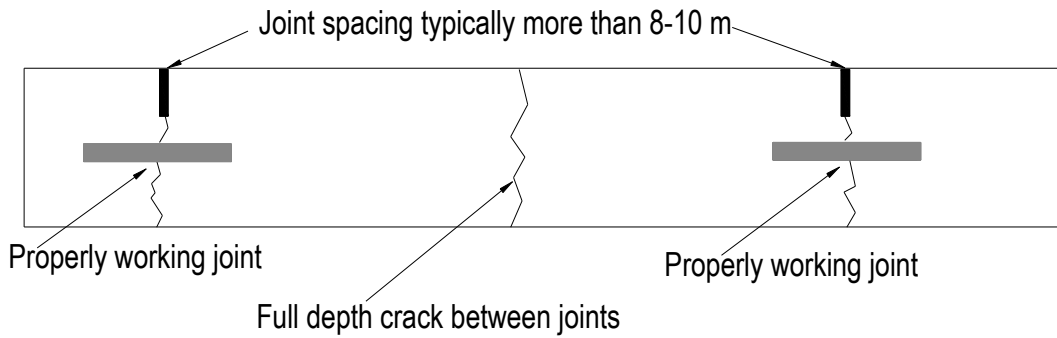
**Fig. 1 Mechanism Necessary for Cracking due to Long Joint Spacing**

Pavement with long transverse joint spacing may crack at locations other than the saw cuts due to tensile stresses from temperature curling (fig. 1). Theoretical and practical studies of concrete pavement have determined that the optimal spacing between joints depends on the slab thickness, subbase stiffness, and concrete strength. Most of the time the spacing of transverse contraction joints in plain pavement is kept 4.5 m to 6.0 m. It is also important to check the transverse and longitudinal contraction joint spacing to see if it is within the limits as described in various codes and specifications. For unreinforced concrete slabs, IRC:15-2002, recommends maximum contraction joint spacing of 4.5 m up to 25 cm thick slabs and 5.0 m for 30 and 35 cm thick slabs.

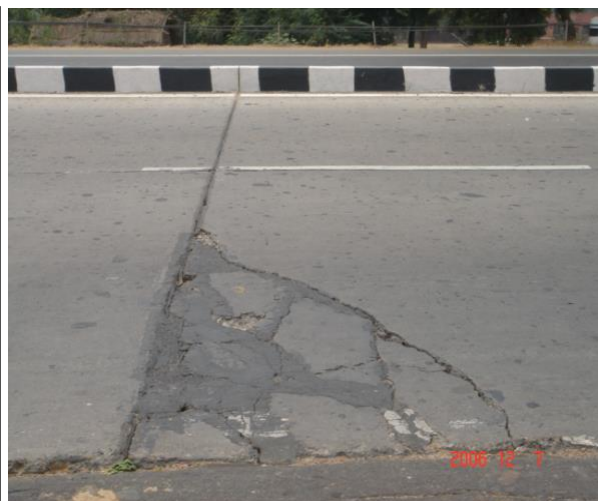
**Photo 5. Corner Cracking**

Corner cracking is normally prevalent only in thin slabs and slabs with acute-angled corners (Photo 5). In both the cases the stress is very high in the corner region as compared to elsewhere. If the pavement thickness has been designed adequately, such corner cracks will not occur.
